GEORGE C. TOLAND

November 21, 1992

ANNUAL INSPECTION OF QUAIL SPRINGS FILL DAM
GOLDSTRIKE MINE
WASHINGTON COUNTY, UTAH
FOR TENNECO MINERALS

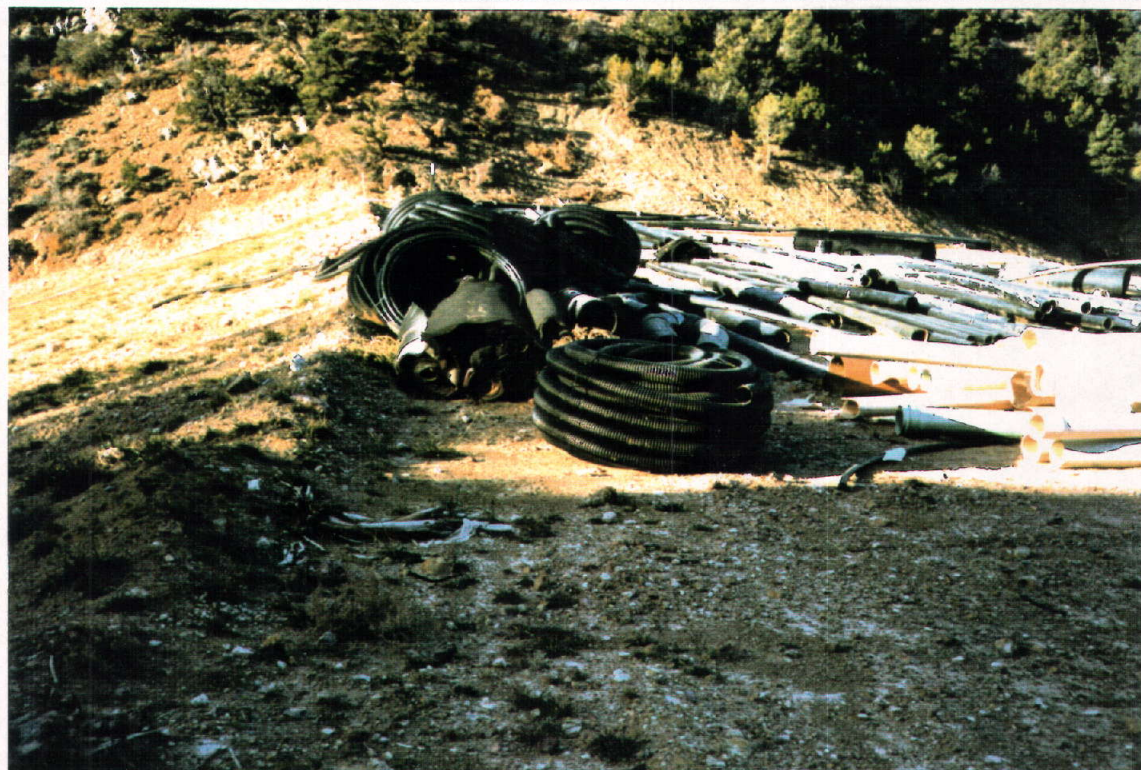
The crest of the dam is now being used as a storage area (see Photograph 1). The upstream face of the dam will not have wave erosion and has been seeded in grass (see Photograph 2). The downstream face of dam is a flat area that contains a haul road and a leach pad (see Photograph 6).

PHOTO 1: WIDE CREST OF DAM WHICH TIES TO HAUL ROAD AND LEACH PAD.

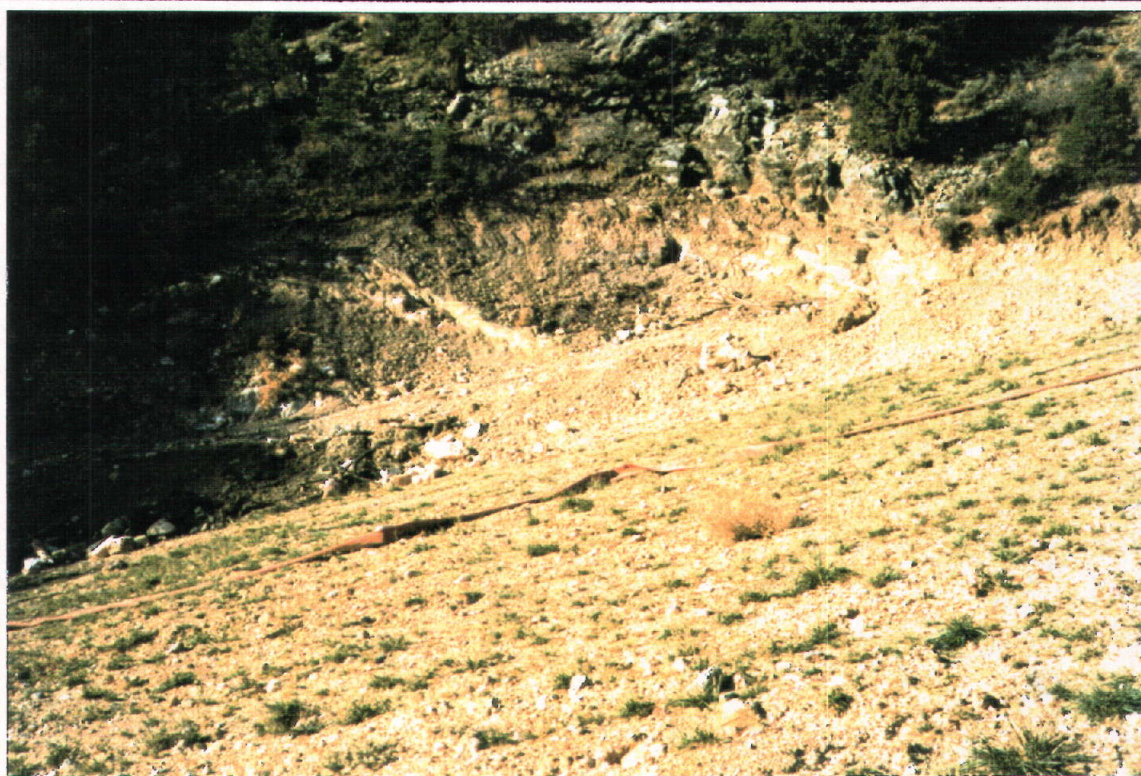
PHOTO 2: UPSTREAM FACE OF DAM.

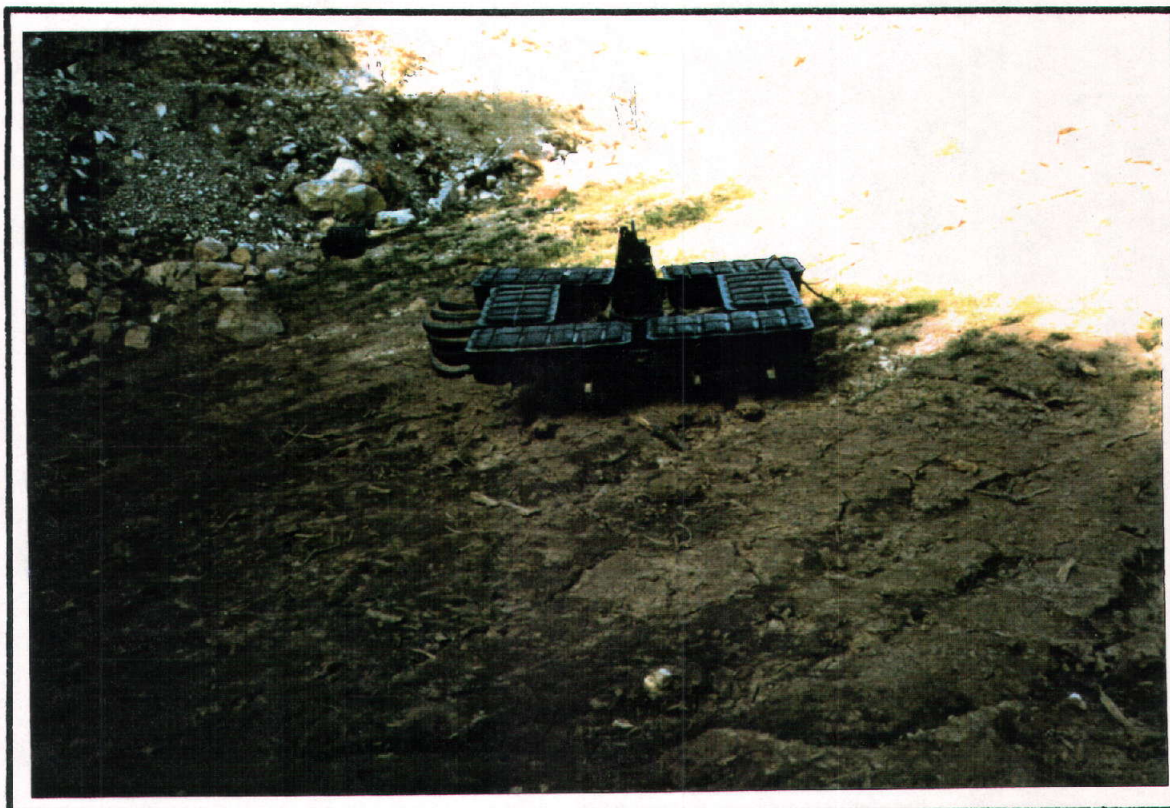
Photograph 3 shows the barge pump that is maintained to empty any flood water that may build up in the reservoir. The emergency spillway flows directly onto the haul road on a flat slope that will not be subject to erosion (see Photograph 5). The 1991 and 1992 rainfall has been far above normal at the Goldstrike Mine. Pumping has been used this year to remove flood water from the reservoir. However, in normal rainfall years pumping will likely not be required.

PHOTO 3: PUMP BARGE WHICH REMOVES STORM FLOW.

The Quail Springs Fill Dam and reservoir is performing well. There was no indication of stability or seepage problems. Tenneco Minerals personnel should continue to observe the dam and reservoir, and should report any seepage or embankment movement to our office. The barge pump should be maintained to remove ponded water from the reservoir during the mining operation.

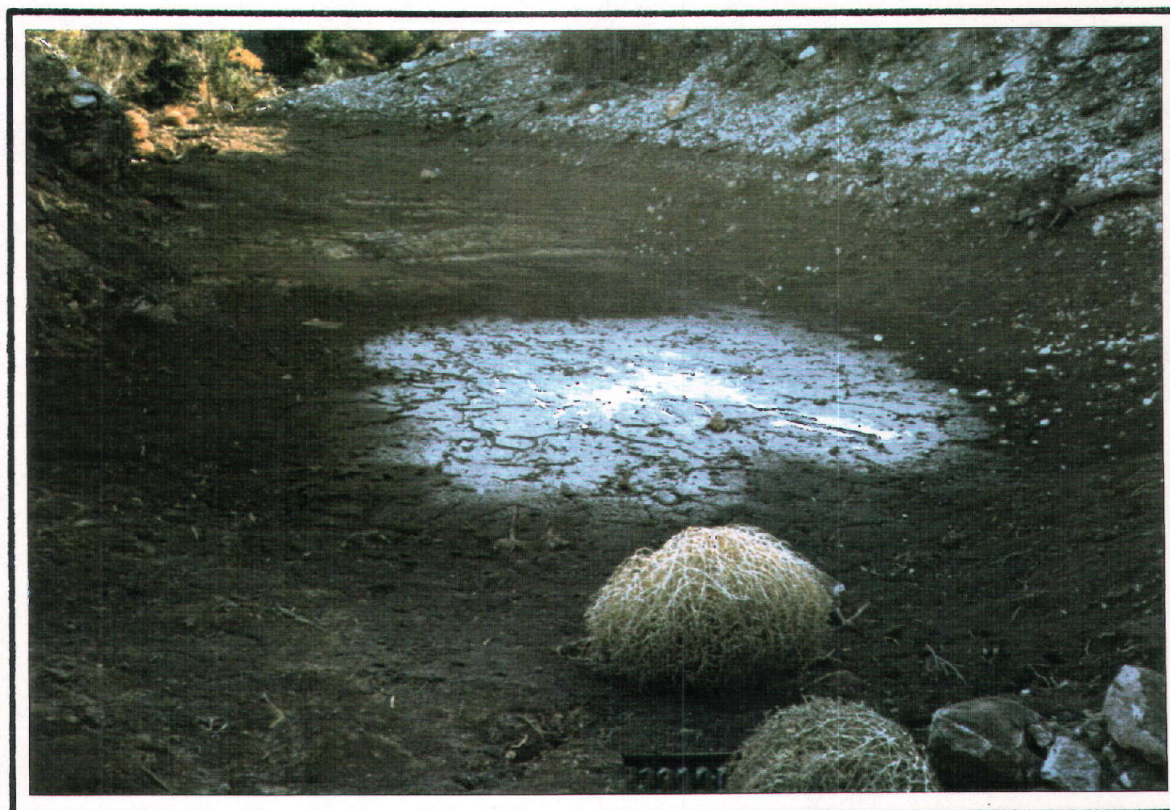
PHOTO 4: DRY BOTTOM OF RESERVOIR.

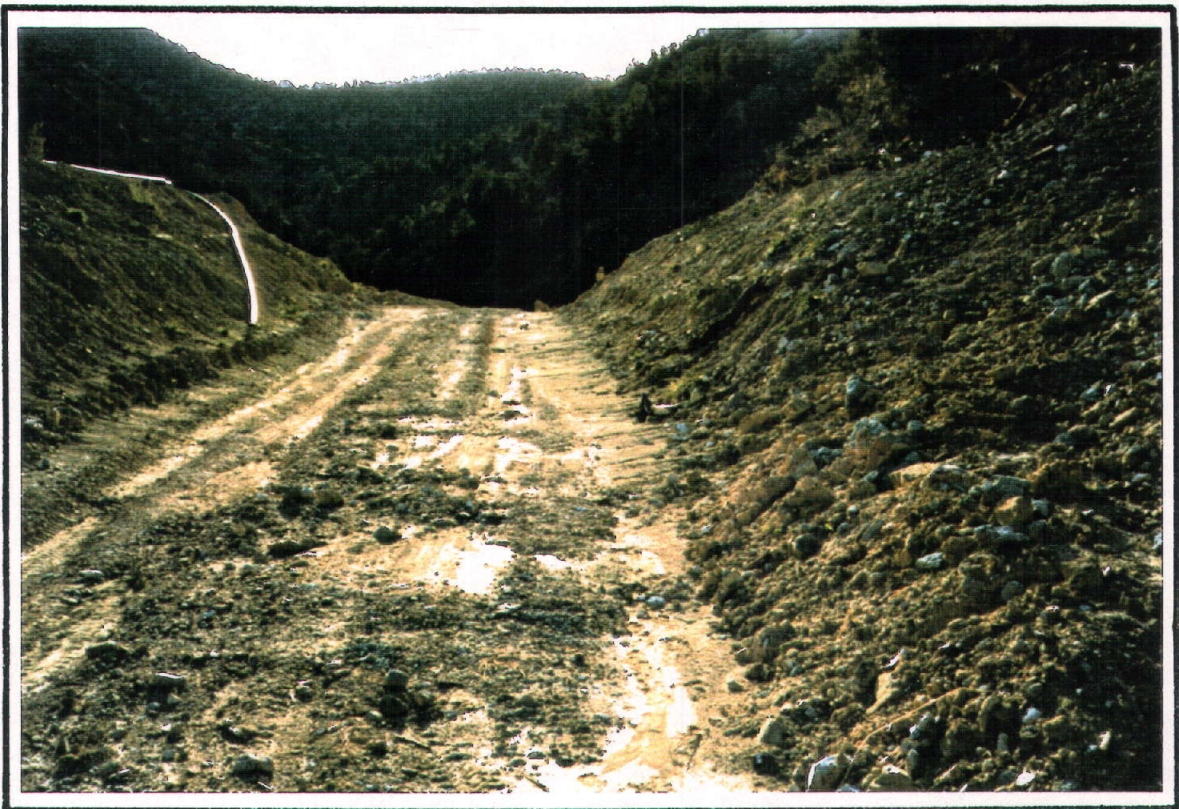
PHOTO 5: EMERGENCY SPILLWAY

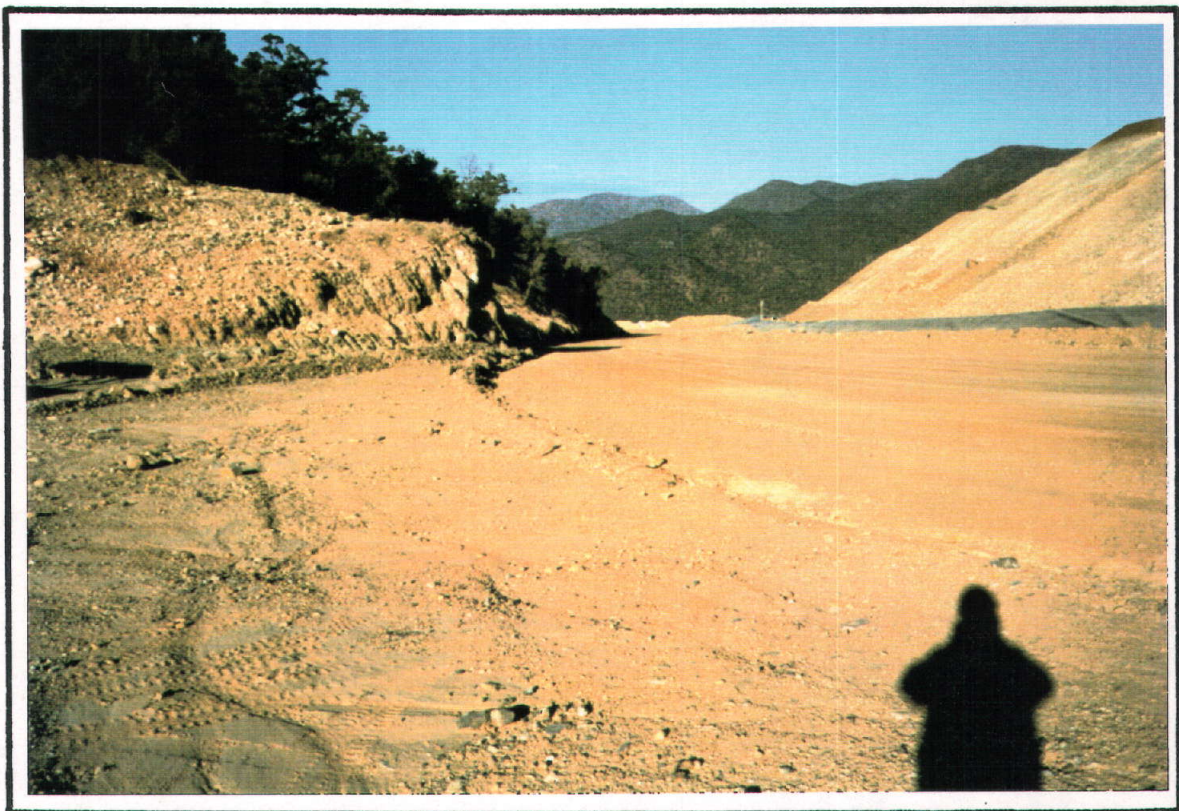
PHOTO 6: HAUL ROAD AND LEACH PAD AREA BELOW SPILLWAY.
